**CANADIAN FORCES
FLIGHT SAFETY INVESTIGATION REPORT (FSIR)**

FILE NUMBER: 1010-CT114172

AIRCRAFT TYPE: CT114172-CT114006 Tutor

CATEGORY: "C" Category Accident

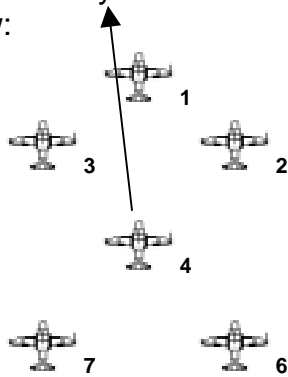
As the second element was positioning for rejoin, pilot #1 called a speed reduction and 'easing right' into the turn. On rejoin, aircraft #4 overshot aircraft #1 as depicted by the arrow in the diagram above.

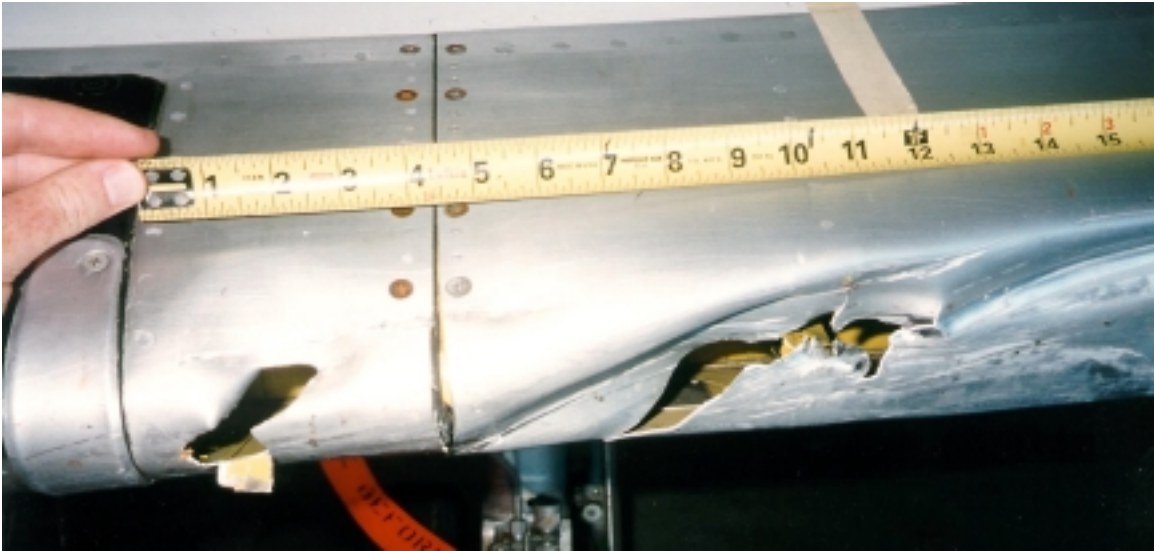
Aircraft #1, CT 114006, sustained "C" category damage in that the left leading edge was dented and torn requiring replacement. Aircraft #4, CT 114172, sustained "C" category damage to the top and left side of the T-tail, requiring replacement. (Annex A)

Aircraft #1's left leading edge showed denting, rub marks and two areas of tears outboard of the landing light for approximately four feet (Annex A, photo #1). Aircraft #1 also had dents on the left smoke tank. Aircraft #4's tail, top and left elevator, showed torn and dented surfaces including deformation approximately four inches downwards of the left elevator (Annex A, photo #2). Comparison of these damaged areas shows that aircraft #4's 'T' tail impacted both the smoke tank and leading edge of aircraft #1.

Photo 1: CT114006 Left Leading Edge

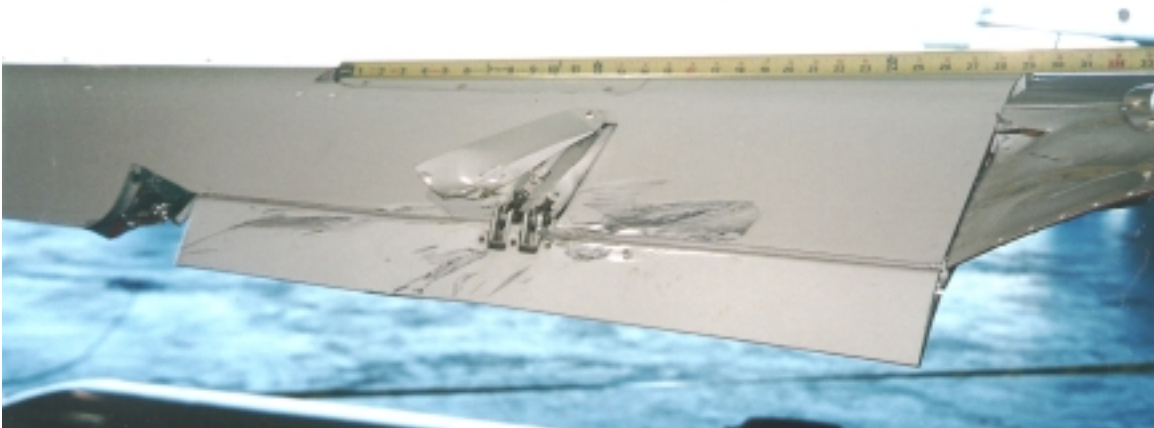
Photo 2: CT114172 Left 'T' Tail
